The Locomotive

VOL. XXVIII. HARTFORD, CONN., JANUARY 25, 1910.

The Milwaukee Boiler Explosion.

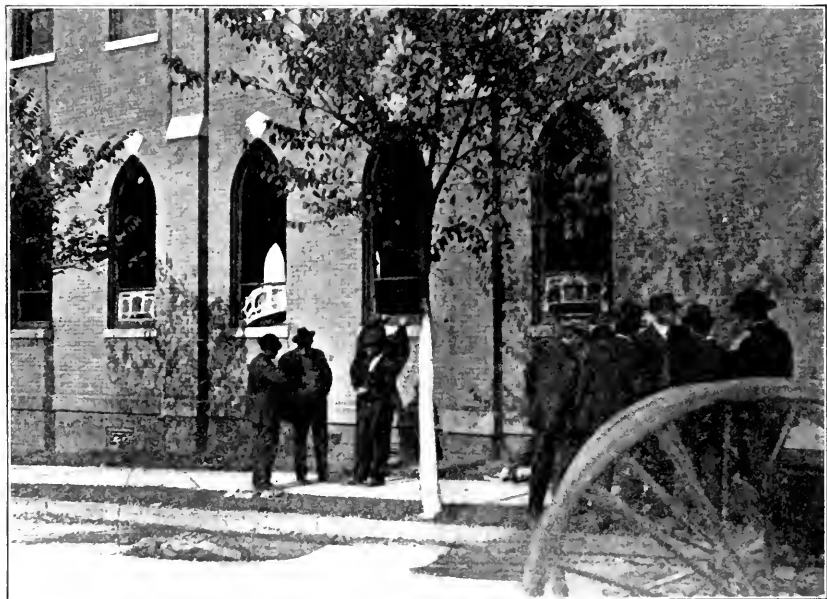
FIG. 2.— EXTERIOR OF CHURCH, SHOWING WRECKED MEMORIAL WINDOWS.

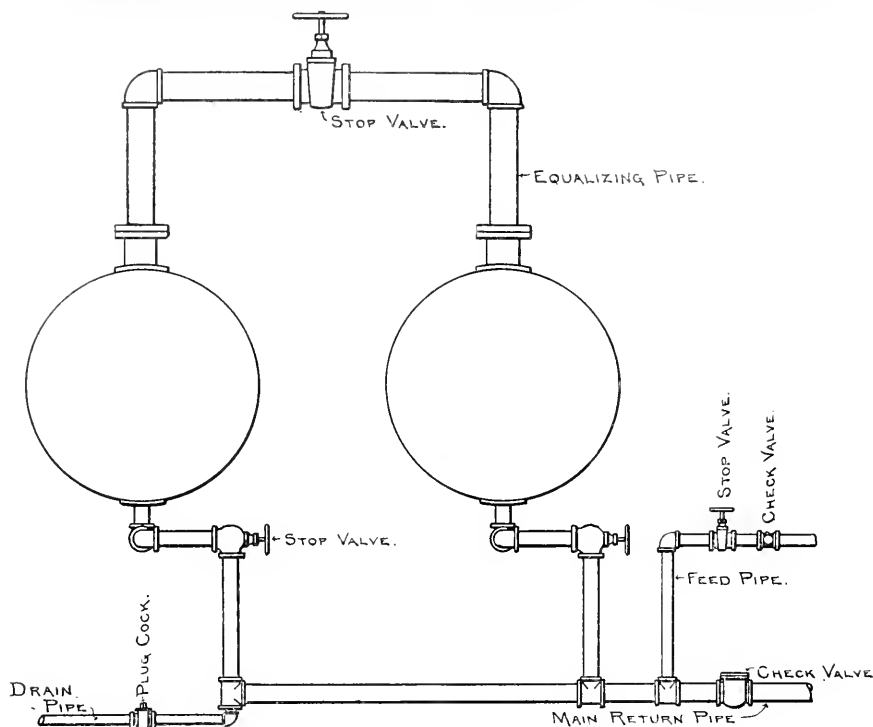
FIG. 1.—ARRANGEMENT OF RETURNS WITH EQUALIZING PIPE.

The return pipes of the various boilers should be connected to a common return line, with stop valves for each boiler. A check valve should be placed in the return line on the building side of the branches to the boilers as shown in Fig. 1, to prevent water flowing back to the radiators and piping when the main steam valve is closed, as discussed in the October 1912 LOCOMOTIVE. There

should not be any check valves in the branches to the boilers, since the return pipe acts as an equalizer below the water line and should afford a free connection between the boilers at all times unless the special condition described below exists, requiring the closing of the equalizer valves. *If only one of a group of boilers is working on the system, the equalizer must be shut off if the dead boilers are cut off from the steam and return lines. If, however, the dead boilers are still connected to the system whether or not their fires are burning, the equalizer (and return valve) must be open to prevent the dead boilers from filling with water at the expense of the one which is working.* This would probably result in serious over heating of the metal of the working boiler.

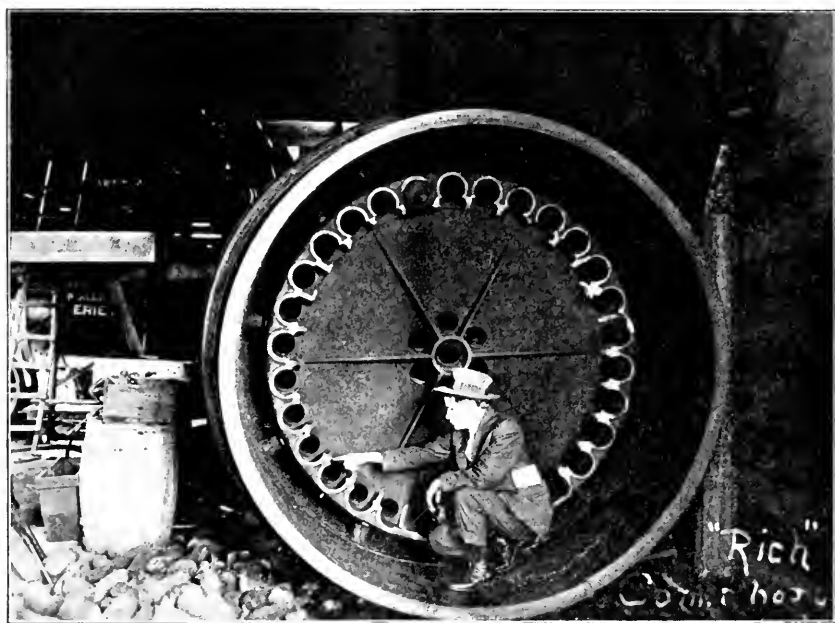
FIG. 3.—THE INSIDE OF THE EXPLODED DRYER HEAD.
THE MAN IS POINTING TO ONE OF THE OLD BREAKS.

We are told that in this case, the dryer had been bought at second hand and without inspection. It had developed leaks at the tube ends a few days prior to the explosion which had been repaired by a boiler maker. It is also said that it was not provided with a pressure gage, reducing pressure valve,

safety valve or proper drain connection. This would indicate several possible reasons for its failure. The fact that it was inadequately drained would have permitted it to fill with water up to the level of the central axis when idle, and when steam was turned on a violent water hammer might have been produced. Then it could easily have been subjected to a severe and unknown over pressure, due to the absence of the ordinary safety devices. The very violence of the explosion, which killed three men and seriously injured a fourth, and which carried the heavy head seen in Fig. 2 a distance of 350 feet—the head was said to have weighed some 1200 lbs.—would indicate that the vessel must have contained considerable water which added its heat energy to that in the steam, when the explosion occurred. A number of old and deep cracks were found in the reinforcing webs which surrounded the tube ends in the outside row. The man seen in Fig. 1, is pointing to one of them.

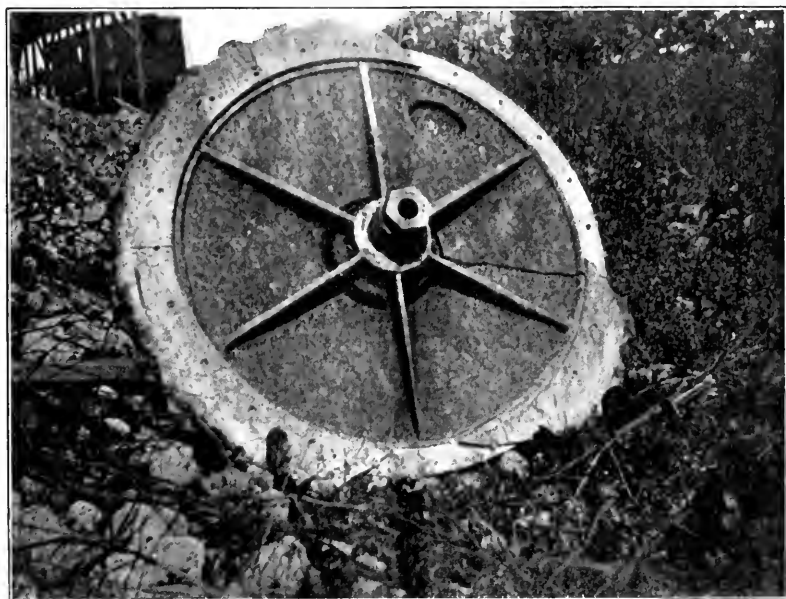
FIG. 3.—REVERSE SIDE OF OUTER HEAD.

Cast iron is a treacherous material at best to use in vessels under steam pressure if it must carry any of the stresses involved. But the combination of cast iron, possible water hammer, and excessive pressure in an old and defective structure which had apparently been installed and operated without a knowledge of the precautions necessary for safety, proved, as was to have been expected, a very hazardous affair.

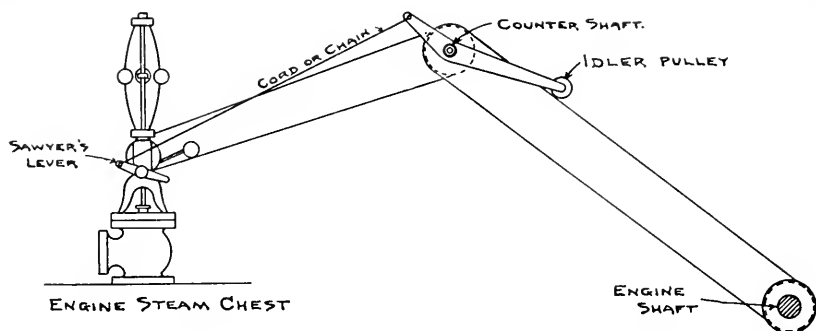
FIG. 1.—SAFETY DEVICE FOR A COUNTERSHAFT DRIVEN GOVERNOR.

When conditions compel the use of a counter-shaft with an additional belt to drive a throttle valve governor, it is very important that precautions should be taken to insure free action of the automatic safety stop. So that it will stop the engine if either of the two belts should break. So many cases have come under our observation where no provision has been made for such an emergency, that it may be well to call attention to the proper way to connect up governors operated in this manner. Of course, it will be understood that reference is now made to the throttling governor with an automatic safety stop attachment. This safety stop is designed to be operated by an idler pulley, which rides on the governor belt, and is so arranged that should the belt break, the idler will drop to a lower position, thus tripping the safety latch, and allowing the throttle valve to close.

When it is necessary to use two belts, as noted above, it is evident that the automatic safety stop on the governor will not operate if the belt that runs from the engine shaft to the counter-shaft should break. In this case, the governor would stop revolving and drop to its lowest position, allowing full steam admission to the cylinder, which would result in the engine racing. To obviate this danger, a second idler pulley similar to the one attached to the governor should be provided to operate on the belt leading from the engine to the counter-shaft, as shown in the accompanying sketch. This can be fitted with very little trouble or expense by the engineer or other mechanic about the plant, as the outfit only consists of the pulley and arm with cord or chain to attach to the Sawyer's lever on the governor, which also operates the safety stop. When thus connected, the governor can then be relied upon to stop the engine if either of the belts break.

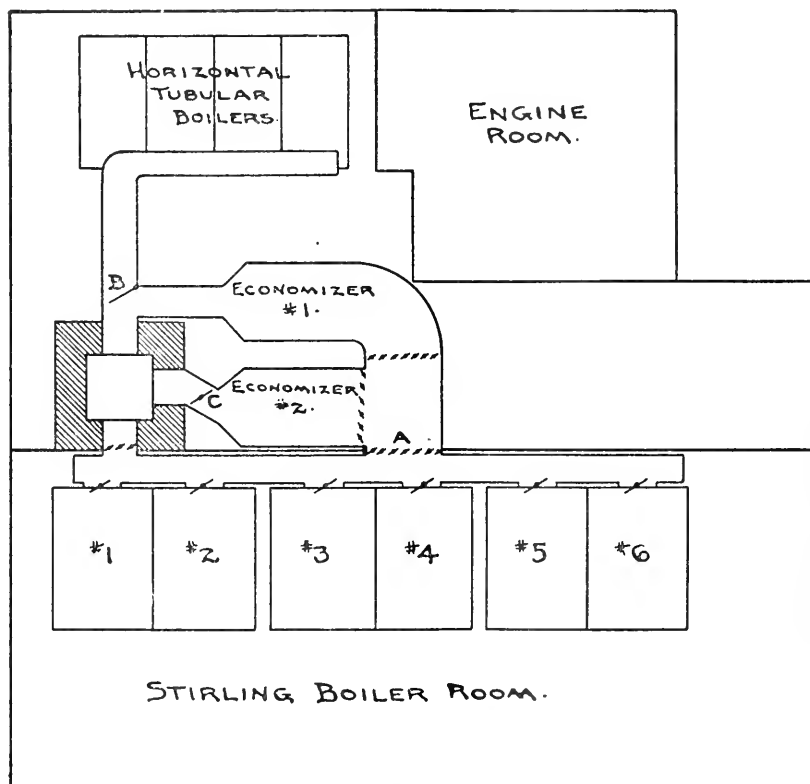
FIG. 1. PLAN SHOWING ARRANGEMENT OF BOILERS AND ECONOMIZERS.

The arrangement of the boiler house and its equipment, as it existed before the accident, is shown in our sketch plan, Fig. 1. There were two boiler rooms, one containing six 325 horse-power Stirling boilers, and the other containing the stack, the economizers, and a battery of four horizontal tubular boilers, together with the feed heaters, pumps, fans, fan engines, and other boiler room auxiliaries. As will be seen, only the gases from the Stirling boilers could pass through the economizers, while those from the tubular boilers went direct to the stack. The economizers, two in number, were behind the stack, and side by side, parallel to the division wall. They rested on a platform about 10 feet above the floor. This platform consisted of longitudinal I beams, between which were turned brick arches, and these in turn rested on transverse I beams,

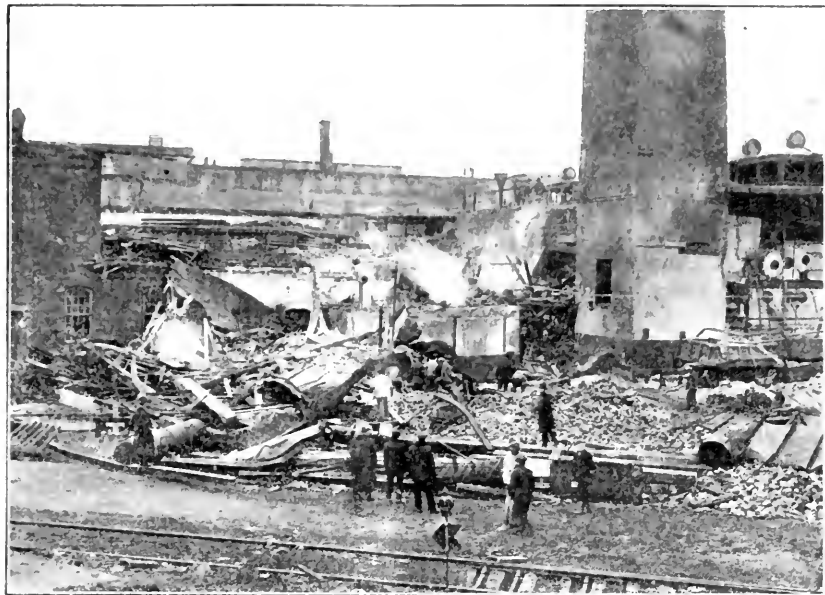
FIG. 2. GENERAL VIEW OF THE WRECKAGE.

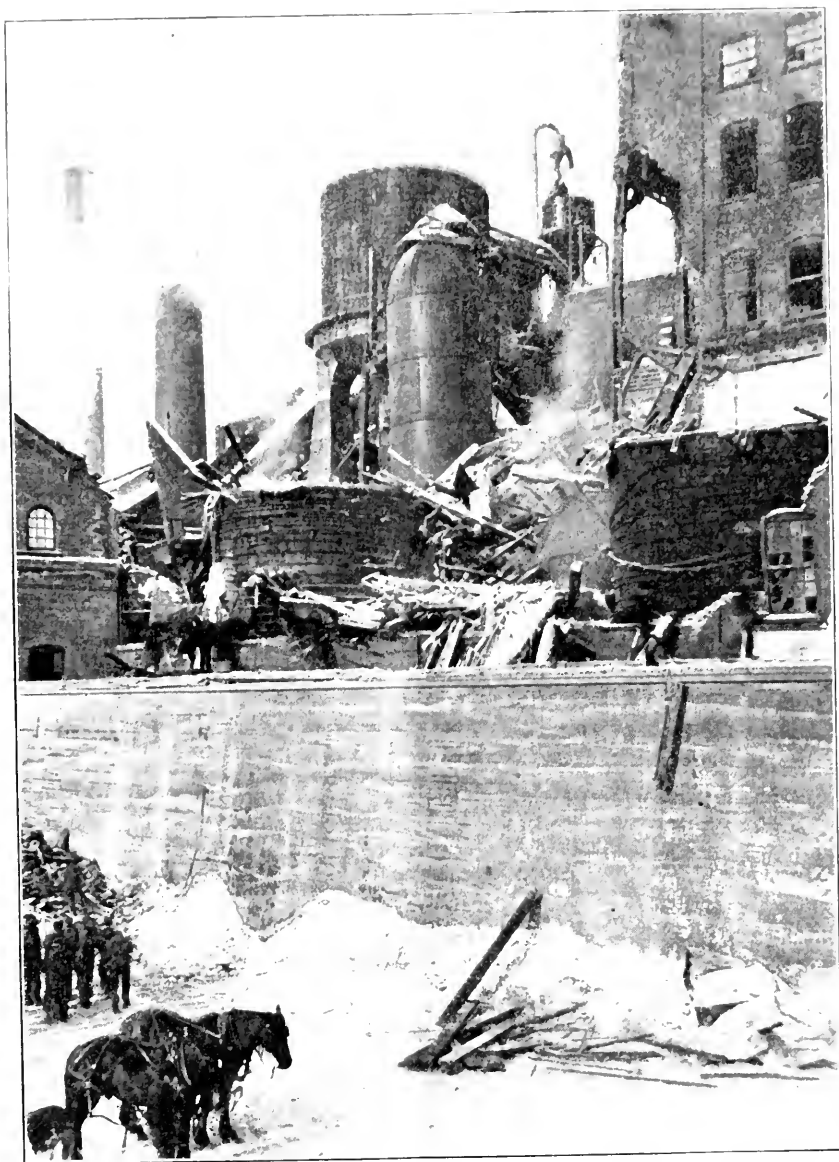
FIG. 1. GENERAL VIEW OF THE DESTRUCTION AT GRAND MERE.

minimum. Figs. 1 and 2 will give a general idea of the extent of the damage.

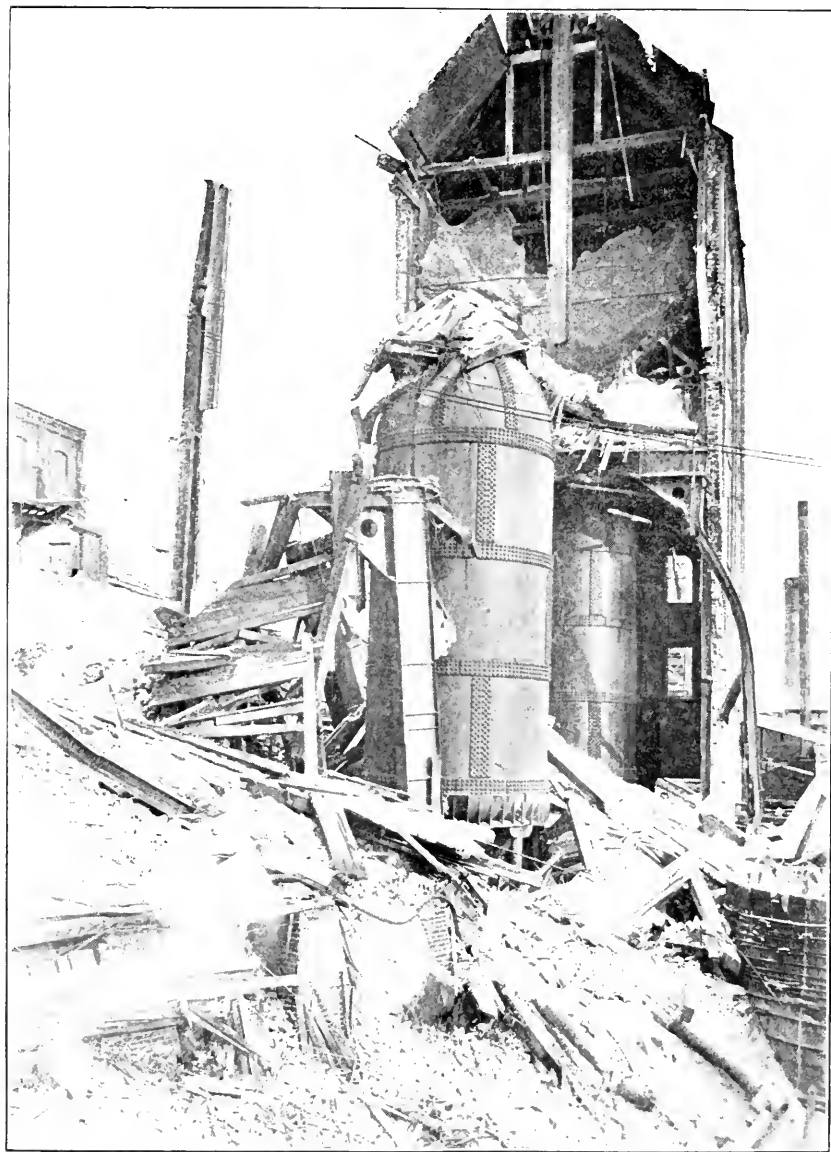
FIG. 2. VIEW LOOKING INTO THE WRECKED DIGESTER HOUSE.

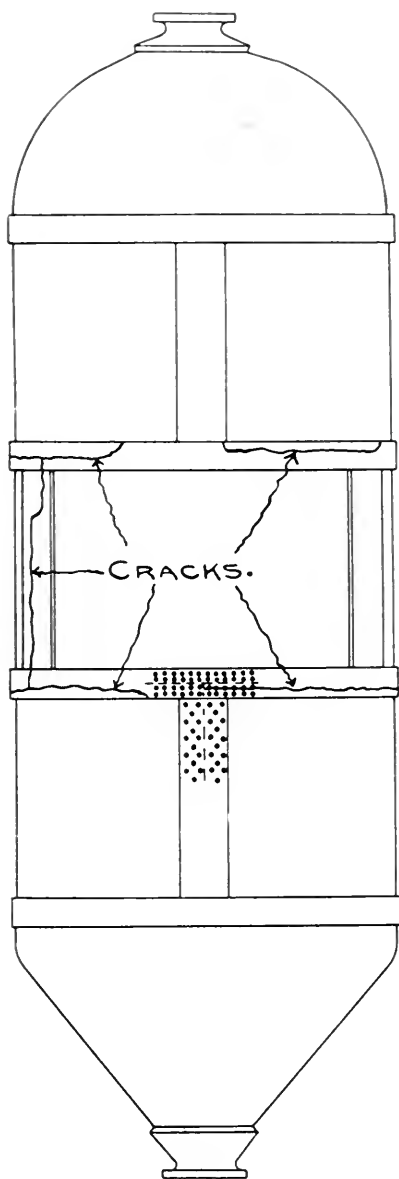
FIG. 3. ELEVATION OF DIGESTER SHOWING LOCATION OF THE LINES OF FAILURE.

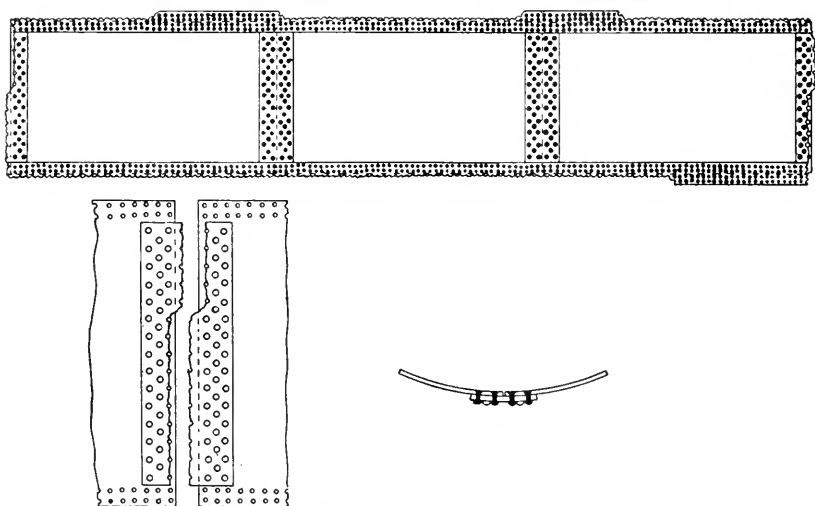
FIG. 4. DETAILS OF COURSE WHICH FAILED.

A close examination of the parts of the wrecked digester gave evidence that the initial failure had occurred at the cover plate of a longitudinal seam on the center one of the three cylindrical courses. These digesters were all of a construction common at the period when they were installed. Because of the lead lining, it was regarded as essential that the inside surfaces should be flush. The joints were accordingly made by butting the sheets and with a single outside cover plate over the joints. In the exploded digester one of these cover

plates had failed by cracking along the line of the rivet holes, and from the direction in which the exploded sheet was thrown, it was evident that this cover plate was the place of initial failure. In tearing from the other sheets, in every case cover plates failed while the sheets themselves did not. This is well brought out in Figs. 3 and 4, which show the way in which these cracks ran along the straps. As these plates were thicker than the sheets and should have been expected to withstand the greater strain, their failure to do so suggested an inferiority of material which an analysis has confirmed. Fig. 5 shows one other strap on this course which cracked but did not let go. Strangely enough the interior of the steel shell showed no corrosion. The lead lining, in this case at least, seems to have protected the steel thoroughly.

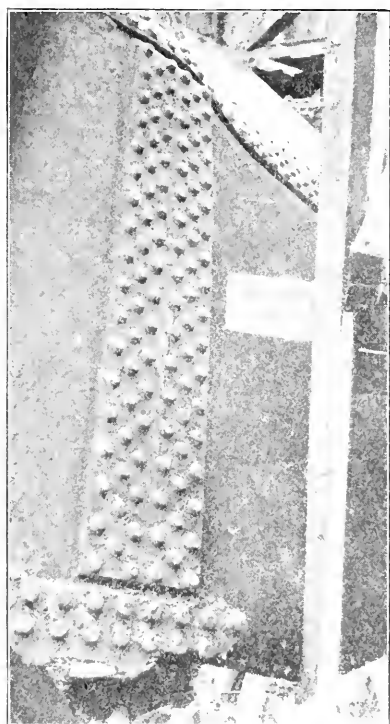
FIG. 5. CRACKED BUTT-STRAP.

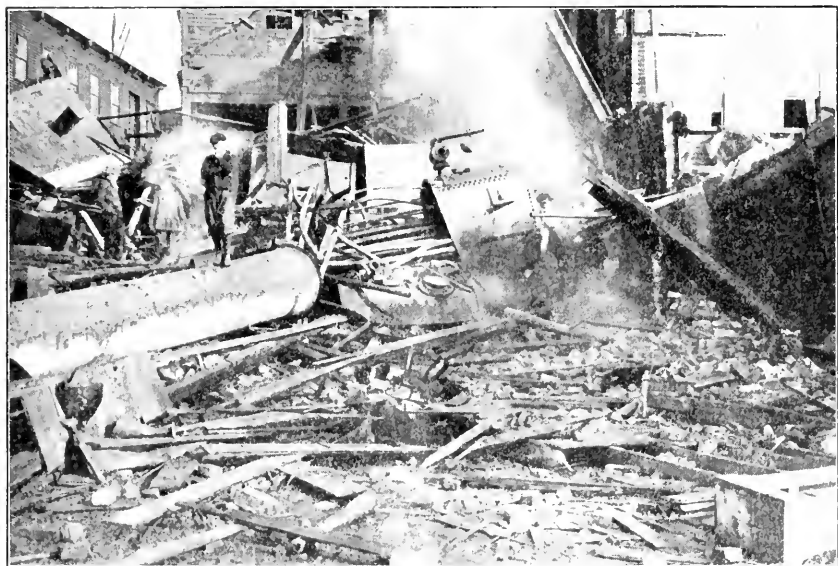
FIG. 1. BOILER EXPLOSION AT KEENE, N. H.

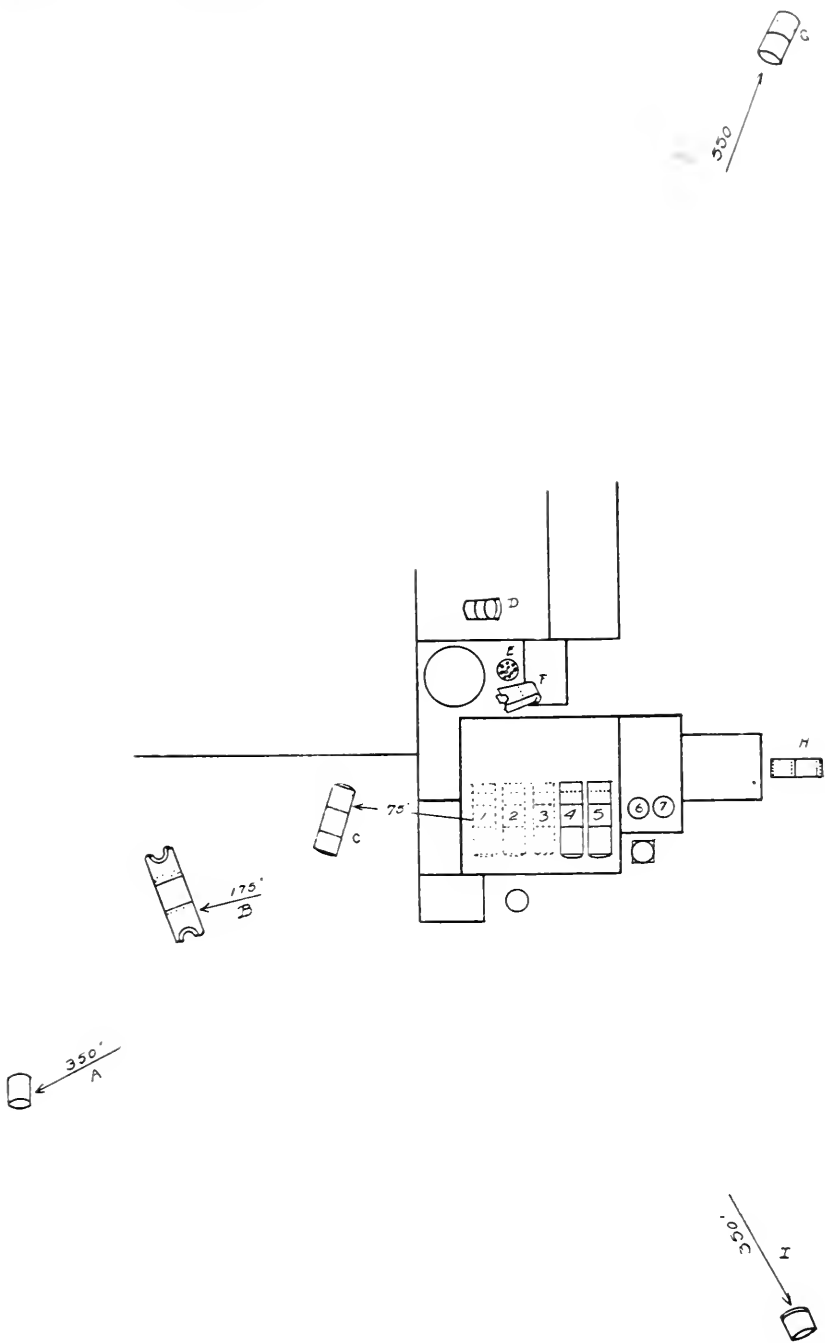
There is some doubt as to which of the boilers first gave way. Witnesses testified to a double report like two pistol shots in rapid succession. It is probable, from the appearance of the failures, that one of the boilers exploded first, and struck its neighbor a blow of sufficient violence to set it off. Both the exploded boilers were of lap seam construction, built in five courses with outside cast iron man-hole frames attached to the third course. Both of them failed through the man-hole frame, and each man-hole course was ripped longitudinally from girth seam to girth seam, through the center line of the man-hole open-

FIG. 1. PATHS OF PROJECTED BOILER COURSES.

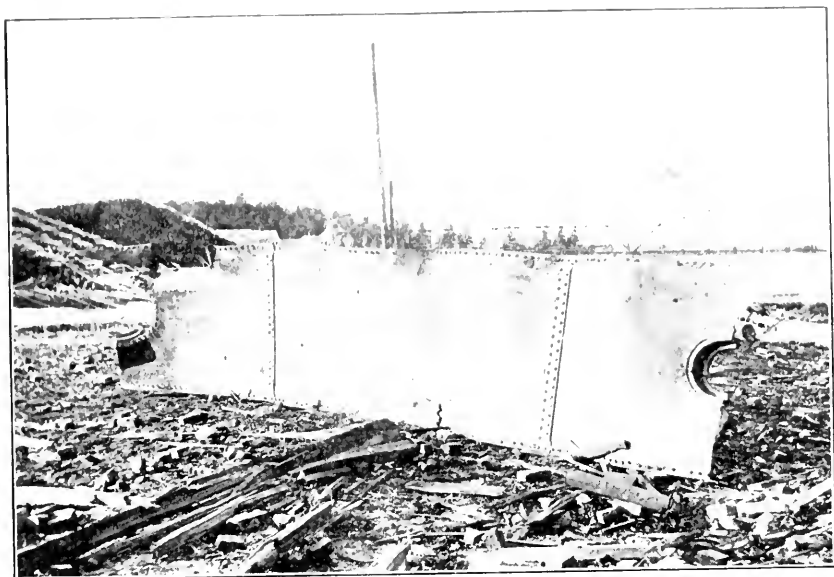
FIG. 3. RUPTURED MANHOLE COURSE "B."

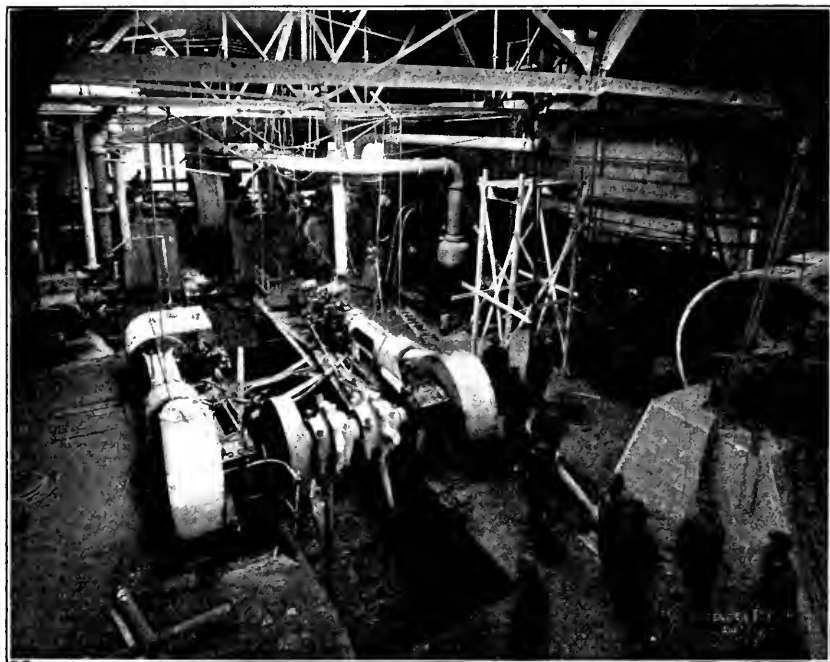
FLY-WHEEL WRECK, ALPHA, N. J.

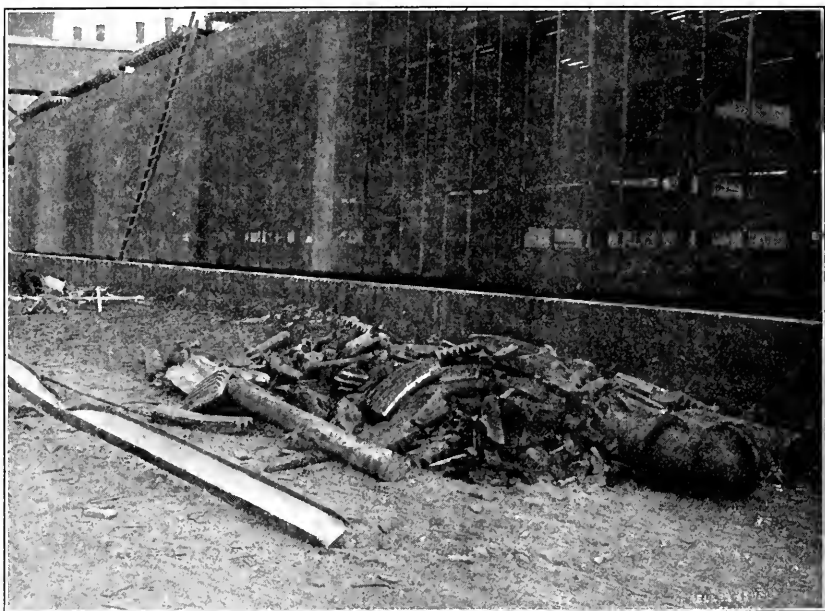
THE REMAINS OF THE FLY-WHEEL, ALPHA, N. J.

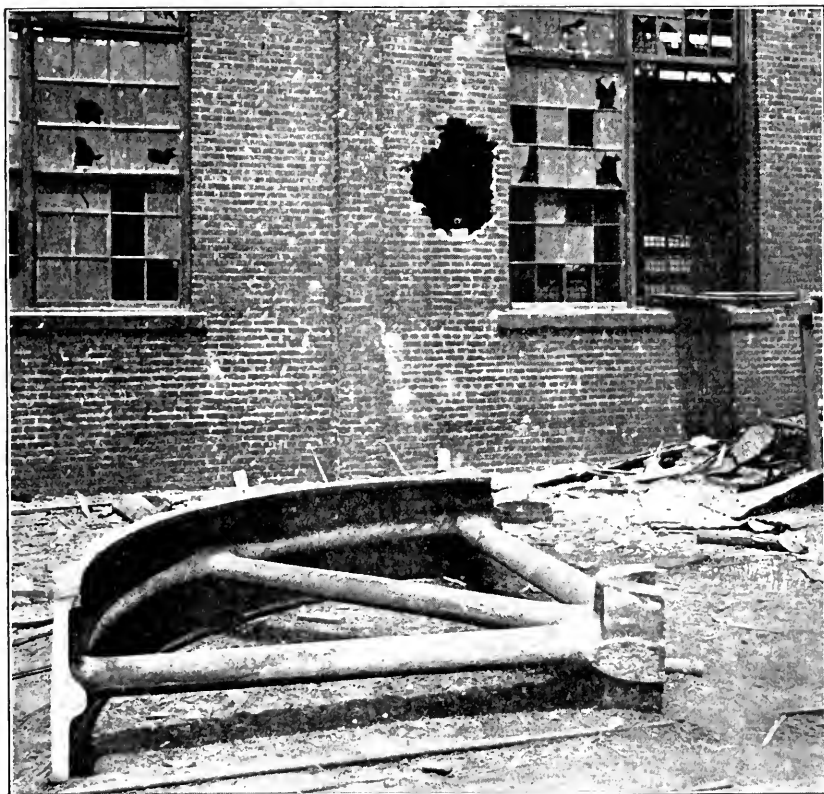
AN UNUSUAL FLY-WHEEL BREAK. BIRMINGHAM, ALABAMA.

A large fly-wheel burst Aug. 20 at the plant of the Payne and Joubert Machine and Foundry Co., Birmingham, Ala. The wheel, which was 15 feet in diameter, with a 26 inch face was of the split type, cast in two sections. It was joined at the rim by bolted flanges, and by the usual bolted construction at the hub. There were eight arms. The wheel served to transmit the load from an 18x36 inch Corliss engine to a generator, by means of a 24 inch belt. The speed was controlled by a fly ball governor of usual type, with a link type safety knock out, arranged for automatic operation in the event of governor belt breakage. The normal speed was 75 R. P. M.

We are told that a considerable peak load on the generator caused the circuit breaker to operate, relieving the engine very suddenly. The subsequent racing was noticed by the fireman and he called to the engineer who had stepped out of the engine room. The engineer, realizing what had happened, ran for the throttle, but only succeeded in getting in the path of one of the larger fragments of the wheel. He was instantly killed.

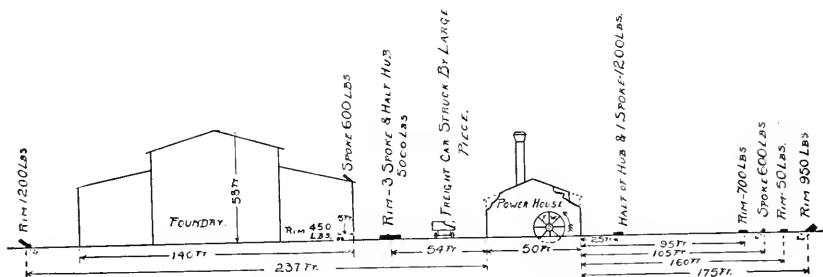
FIG. 1. SHOWING THE COURSE OF THE FRAGMENTS.

Portions of the wheel were thrown both in front and to the rear of the engine, as is shown in detail in our sketch, Fig. 1. The roof and walls of the engine room were badly wrecked, though the roof had been repaired when the photograph Fig. 2 was taken. One large piece passed completely through a gondola car that was standing on a siding alongside the engine room, as our sketch shows.

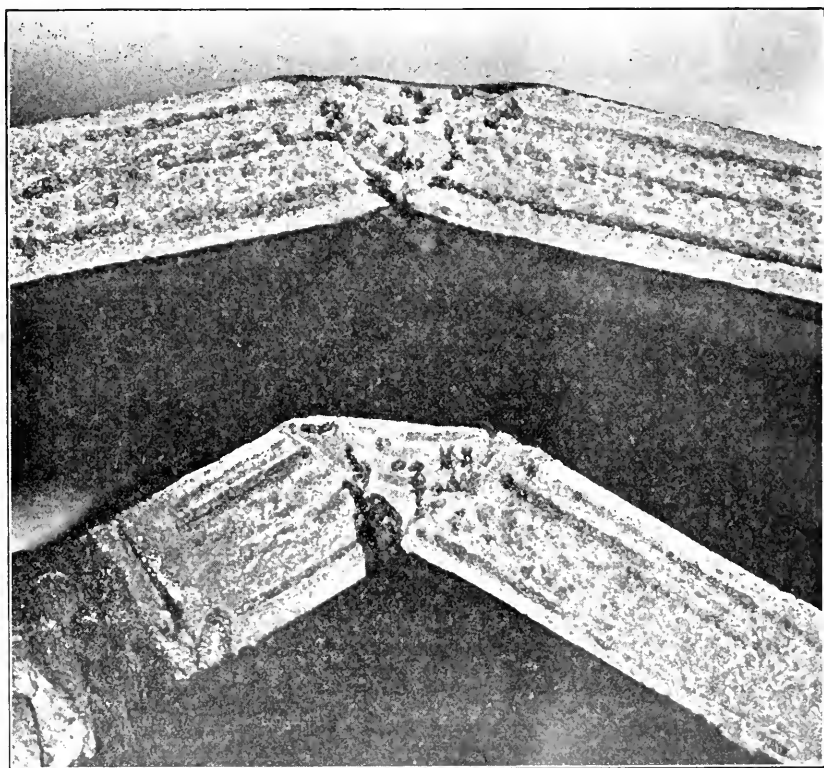
FIG. 1. (Upper.) ETCHED SECTION OF LONGITUDINAL SEAM.

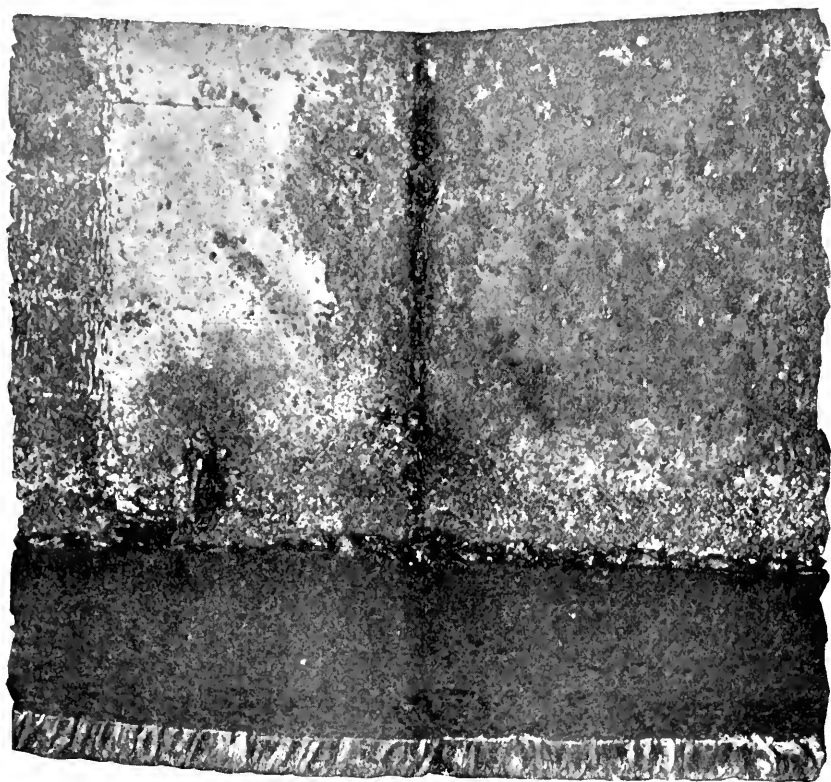
FIG. 3. WELDING OF HEAD TO SHELL. NOTE THE ROUGH CHARACTER OF THE WORK.
